Shake table tests of non-ductile as-built and repaired RC frames

P. Quintana Gallo, U. Akgüzel, S. Pampanin & A.J. Carr

University of Canterbury, Christchurch, New Zealand.

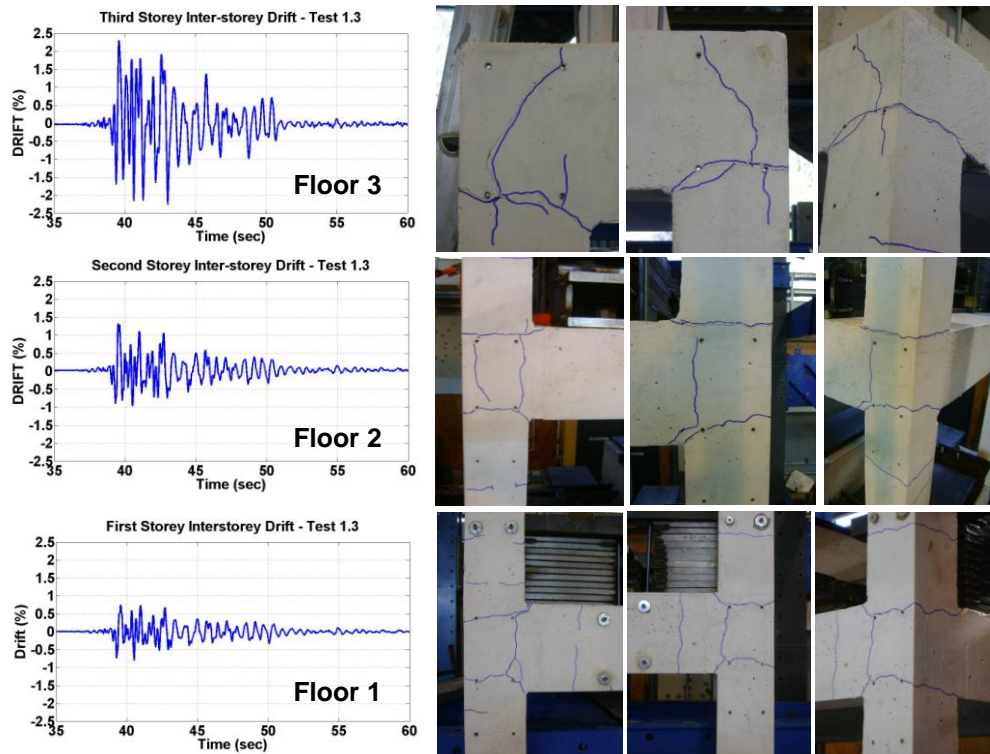
Tests 1.1, 1.2 and 1.3 were conducted in a consecutive sequence, increasing the amplitude of the initial input motion - $\text{PGA} = 0.45\text{g}$, Figure 5 - by a factor of 1.5 and 2.0. During Tests 1.1 and 1.2 (thus up to $\text{PGA} = 0.675\text{g}$) a predominantly elastic response was observed. No evident damage was developed in the structure. During Test 1.3 though ($\text{PGA} = 0.9\text{g}$), a response characterized by excessive lateral deflections of the top floor, almost disconnected from the floors below, was observed. Recorded inter-storey drift time histories for Test 1.1 and 1.2 are presented in Figure 7. In Figure 8 recorded inter-storey drift for Test 1.3 as well as relevant observed damage on the exterior frame are shown. As can be seen in Figure 7, for Test 1.1 at $\text{PGA} = 0.45\text{g}$, inter-storey drifts remained below 1%, being recorded time histories almost identical in all floors. For Test 1.2 at $\text{PGA} = 0.6\text{g}$, no evident increasing in the drift levels was observed at floor one and two, with an increase of the top floor maximum drift level to 1.5%. Time histories responses showed different dynamic response to what observed in Test 1.1, with drift level being fairly similar in all floors. In the case of Test 1.3, top level drift reached a maximum value of approximately 2.5%, whereas drift levels in floors 1 and 2 remained below 1.5%. Experimental time histories reflect a response governed by a top floor storey local mechanism.

Crack pattern indicates that most of the inelastic behaviour occurred at the base of columns affecting the panel zone region. In the columns at the third floor, horizontal cracks developed just above the joint or with little strain penetration, whereas on the second floor, horizontal cracks penetrated significantly inside the panel zone. Vertical cracks and diagonal cracks developed on exterior joints, on both faces. Crushing of concrete was observed on the bottom of third floor columns. This reflects rocking action at the bottom of exterior columns due to loss of bond between concrete and

reinforcement in column lap splices. On top floor joints diagonal cracks developed in the opposite direction to those of floors 1 and 2. In this case, cracks developed following the strut resulting from the beam acting with the slab in compression, whereas on the other, cracks tend to be oriented following the compression strut generated when the slab acts in tension. As can be seen in pictures of Figure 9, when bond is lost in the exterior longitudinal bars of the column, tension capacity is lost in that area. On the interior bars, whose lap splices apparently did not fail, a compression strut was able to be developed in the joint. On top joints on the other hand, the compression strut is developed as expected.

Figure 8: Recorded inter-storey drifts and observed damage – Test 1.3 (Loma Prieta)

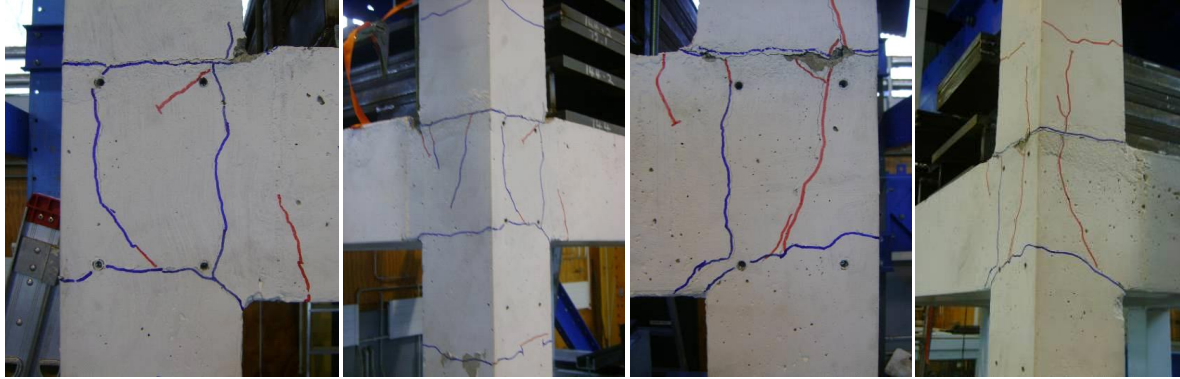
The failure mode described in previous paragraphs was corroborated with the observed damage in the specimen after the Darfield Earthquake that stroke the city of Christchurch on February the 4th 2010. As shown on the pictures of Figure 9, vertical and diagonal cracks in the same direction as observed before on the left corner joint were developed on the right corner joint. Rocking on the bottom of third floor column was clearly reflected by the crushing of the concrete around the column reinforcing rebar. The bi-directional characteristics of the real ground motion can be appreciated in corner beam column joints, where a symmetrical damage pattern was observed. It is important to clarify that, since the actual ground motion affected the specimen in real time, even if the input acceleration is the same in prototype and model domains, time does not accomplish similitude rules. As a consequence the response in terms of displacements, velocity and floor accelerations are much bigger to an equivalent response under the same similitude-compatible input motion.

Figure 9: Observed damage after the real Darfield Earthquake (4th February 2010); new cracks in red.

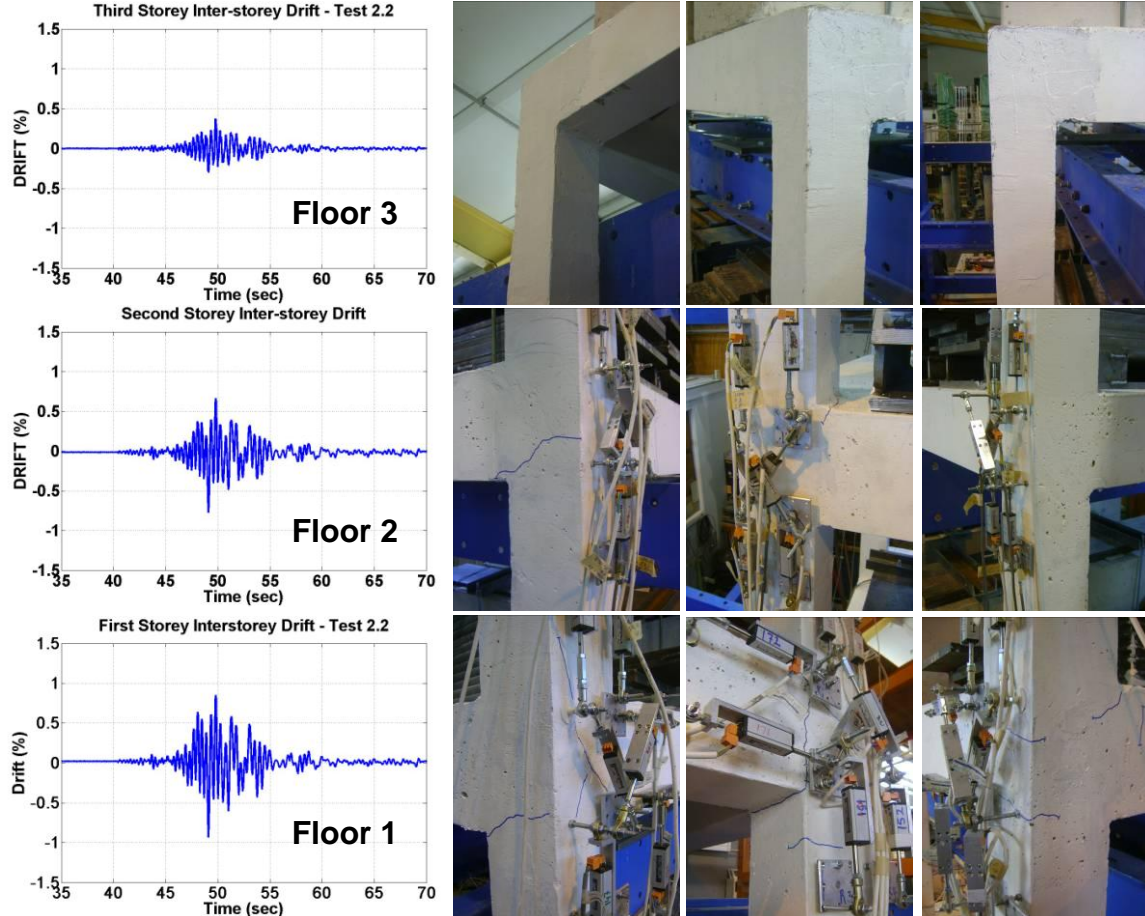
After the specimen was repaired, the ground motion recorded during Darfield Earthquake at Christchurch Hospital was used for Test 2.1 and 2.2. After Test 2.1 at $PGA = 0.17g$, few very thin cracks were observed along the structure. After Test 2.2, with a slight increasing in the PGA to match the actual recorded PGA of $0.20g$, some light cracks developed around the panel zone region and beams, but the structure practically responded in the elastic (pre-yielding) range. Crack patten after the test is shown in the pictures of Figure 11, as well as recorded inter-storey drift time histories at each level.

Figure 11: Damage patten observed after Christchurch Hospital record at $PGA = 0.20g$ (as recorded)

Inter-storey drifts remained below 1% in floors 1 and 2, while at the top floor remained below 0.5%. The shape of the response is mainly identical in all floors, differing only in the amplitude, which decays in upper floors. The response in terms of maximum inter-storey drift values is similar to that recorded during Test 1.3, even though that particular input record had a nominal PGA two times bigger than the one used in Test 2.1. This indicates and confirms that the response in terms of displacement is not necessarily bigger for a ground motion with bigger PGA.

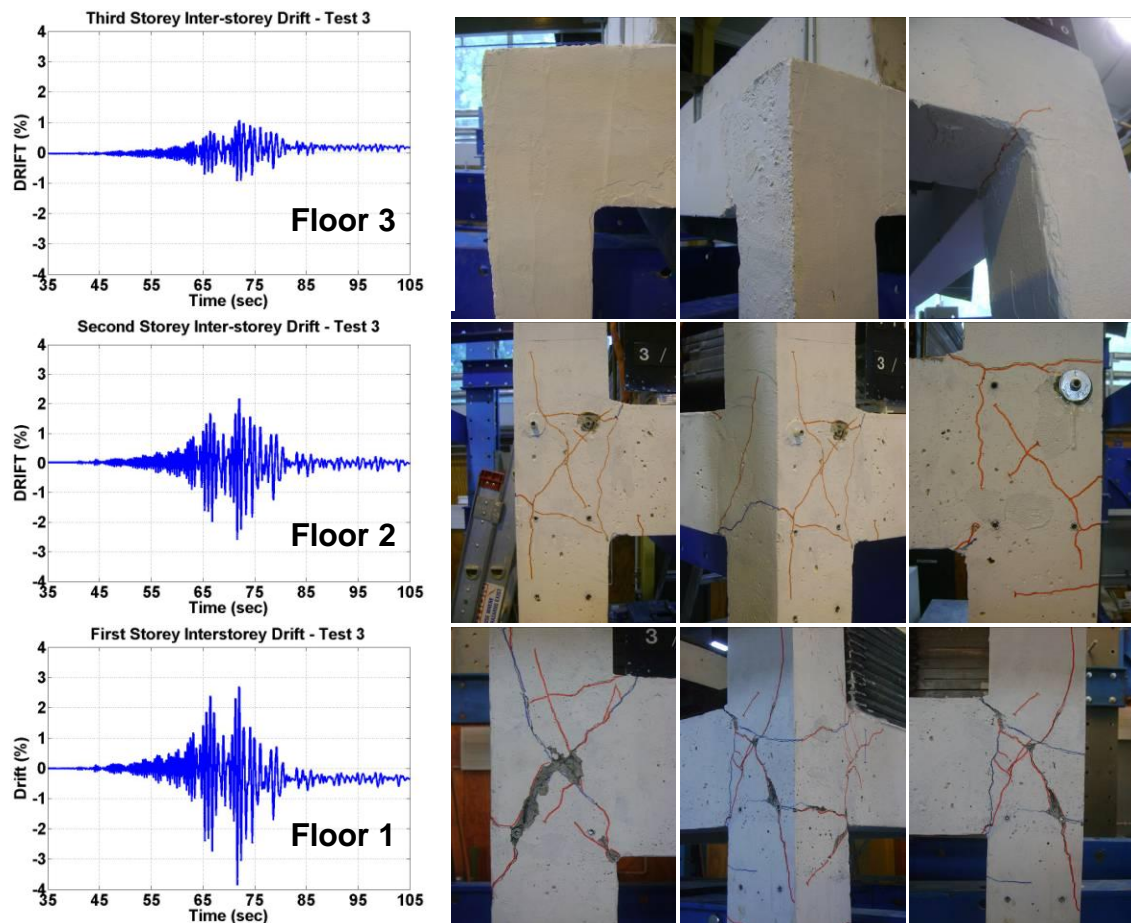
contribution of the seismic hazard for Christchurch. Results in terms of recorded inter-storey drift time histories and observed damage are presented in Figure 12. As can be seen in the pictures, corner joints in the first floor suffered severe damage, and developed the so called ‘concrete wedge’ as a crack pattern. Crushing of concrete in the centre of the joint was also observed. Some cracking was also observed in columns and beams close to the panel zone region. On corner beam column joints of second floor, diagonal cracks were developed, with smaller residual cracks than those measured on the first floor, and no significant crushing of concrete. A maximum inter-storey drift of 4% was recorded on the first floor, whereas a maximum of 2.5% was observed on second floor. In the top floor no significant damage was observed, and a maximum inter-storey drift of 0.4% was recorded. Observations indicated that a first soft storey mechanism was developed, with the structure withstanding a near collapse limit state. Forensic assessment of the building revealed that all for exterior beam column joints of the first floor were severely cracked inside.

Figure 12: Inter-storey drift recorded time-histories, Marga-Marga record, Maule Earthquake at PGA = 0.34g (as recorded)
